NATIONAL DAM INSPECTION PROGRAM. COOKS POND DAM (NDI I.O. PA-00--ETC(U)
1981

PHASE I REPORT
NATIONAL DAM INSPECTION PROGRAM

NAME OF DAM: Cooks Pond Dam
STATE LOCATED: Pennsylvania
COUNTY LOCATED: Bradford
STREAM: North Branch of Beaver Creek
SIZE CLASSIFICATION: Small
HAZARD CLASSIFICATION: High
OWNER: Mr. E. W. Manchester
DATE OF INSPECTION: November 15, 1980 and February 4, 1981

COOKS POND DAM
NDI I.D. PA-0041
DER I.D. 008-035
NOVEMBER 15, 1980

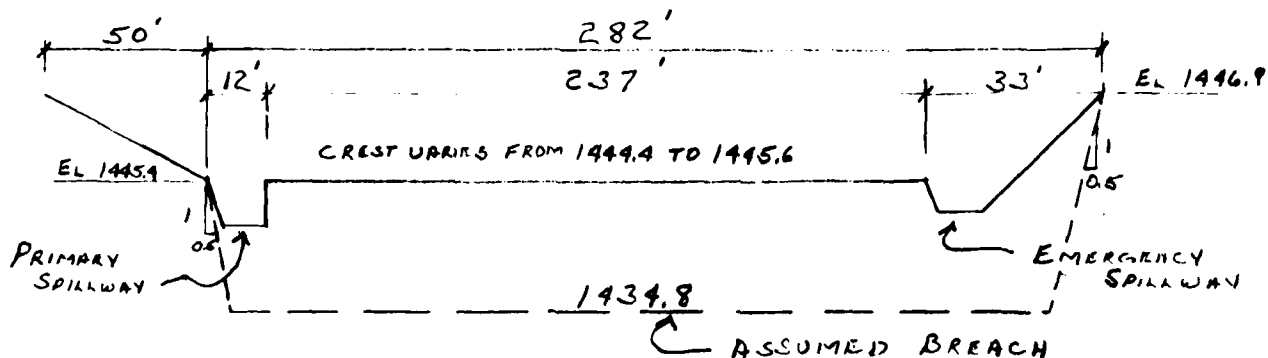
THE DAM BREACH ASSUMED IS:

of life or damage downstream from the dam over that which would exist just before overtopping failure. For the breach analysis, the duration to failure was taken as 0.75 hour and it was assumed that the breaching would initiate when the dam is overtopped by six inches, and the entire embankment would be removed within the failure duration.

BREACH DATA: LENGTH = 282'
DEPTH = 1434.8
SIDE SLOPES = 0.5:1.0 (H:V) (MASONARY)
TIME = 0.75 HOURS

BREACH WILL BE ASSUMED TO OCCUR AT AN
OVERTOPPING DEPTH OF 0.5 FEET
